Repair and Strengthening of Impacted PC Girders on Bridge A4845 Jackson County, Missouri

REPAIR AND STRENGTHENING OF IMPACTED PC GIRDERS ON BRIDGE A-4845

JACKSON COUNTY, MO

Final Report

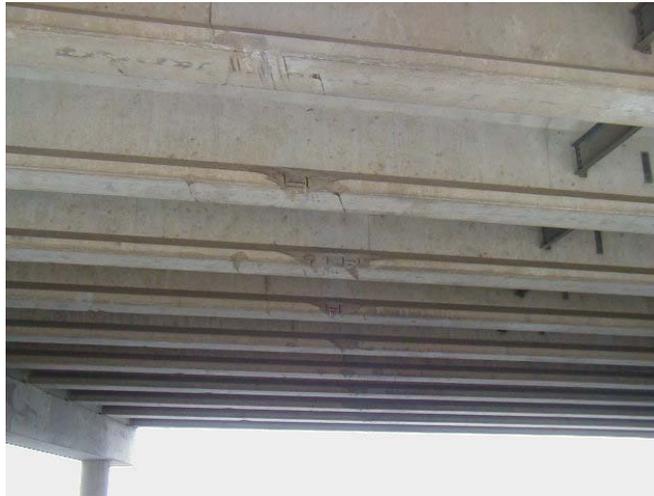
Figure 1 – Impacted Girders on Bridge A4845

Eleven prestressed concrete (PC) girders of Bridge A-4845 located over Route 291 on Route 24 in Independence, MO, were impact-damaged by overhead vehicles causing concrete to spall and exposing rebar and prestressing strands. The location of the bridge is shown in Appendix A.

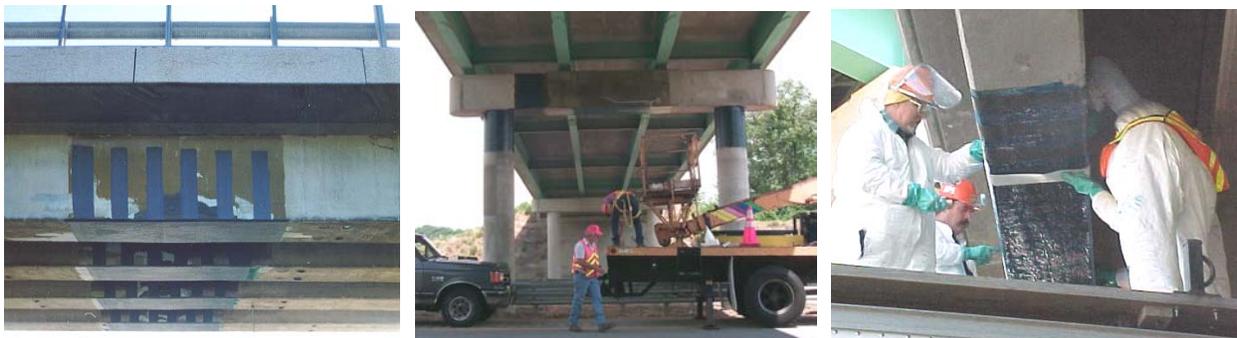
Figure 2 - Examples of Accidental Damage Repair Using FRP Technology

Bridge on Highway Appia

Bridge A3050

Bridge A10062

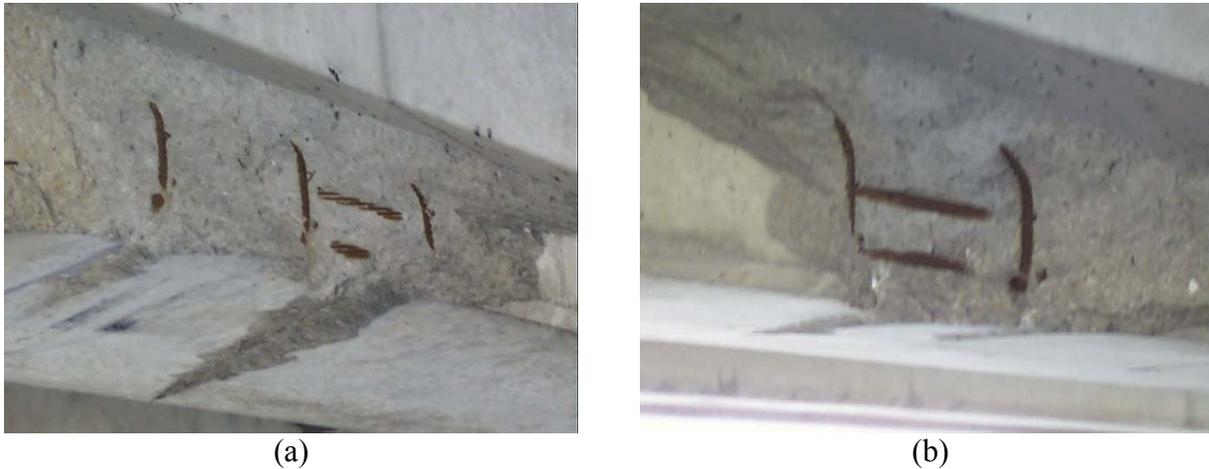
Figure 3 – Exposed Tendons on Bridge A4845

The design for these girders was based on the premise that the loss of ultimate flexural capacity due to the damage to the prestressing tendons in the girders would be provided by the bonded CFRP. The MoDOT inspection crew stated that only three girders had been damaged enough to expose any tendons, and that the maximum number of tendons exposed in a single girder was two (see Figure 3a & 3b).

Girder details were based on the structural drawings provided by MoDOT. The girders are standard MoDOT Type 6 Prestressed I-girders with a total height of 4.5 ft, a top and bottom flange width of 2 ft, and a web width of 6.5 in. Each girder has a total of 24, 0.5 in. tendons with an assumed effective stress f_{pe} of 165 ksi. The concrete strength was assumed to be 4000 psi. The ultimate tensile strength of the fiber composite strengthening system is 550 ksi with a maximum elongation of 0.017 in./in. According to AASHTO, the strength reduction factor for prestressed girders is $\phi = 1.0$.

The factored moment capacity (ϕM_n) of an undamaged composite slab/girder is approximately 4408 kip-ft. Capacity calculations are achieved using an effective slab width of 96.5 in. and slab thickness of 7.5 in. and considering a 1-in haunch between the girders and the topping slab. In order to design the strengthening for the impacted girders two tendons were assumed to be damaged at 50% or one tendon totally broken. The capacity of a damaged girder is 4221 k-ft, making the capacity required for the strengthening to be 187 k-ft.

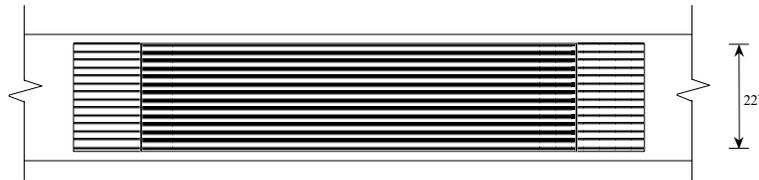
Figure 4 – Details of Longitudinal CFRP Sheets on Girder Soffitt

Side View

Bottom View

It was determined that two CFRP sheets be bonded to the soffitt of each girder. The moment capacity of a girder section after this strengthening is $\phi M_n = 4407$ k-ft. The CFRP will increase the moment capacity by approximately 4.4%. The bonded CFRP, in addition to its structural contribution, will help to prevent deterioration of the repaired areas. See Appendix B for the detailed strengthening design calculations.

The design called for the installation of two plies of 22 in. wide strips of CFRP to the soffitt of each beam. The first ply was 14 ft. in length and the second was 12 ft. in length. Figure 4 below shows a sketch of the longitudinal strip installation. In order to resist peeling of the longitudinal sheets a total of 12 strips of CFRP were wrapped around the bulb of the girders over the length of the repair. These strips are 6 in. wide and extend from the bottom of the web on one side of the bulb to the bottom of the web on the opposite side. The strips are spaced at 16 in. on center. Figure 5 below shows a sketch of the installation of the anchor strips.

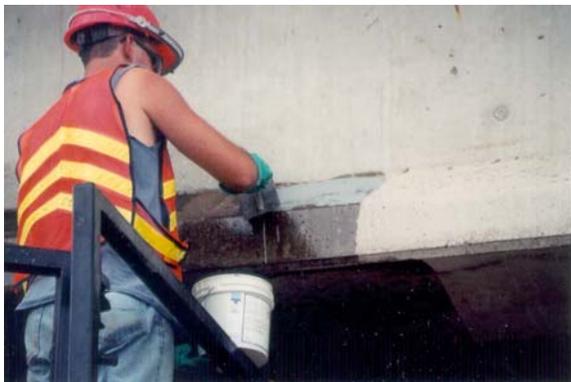
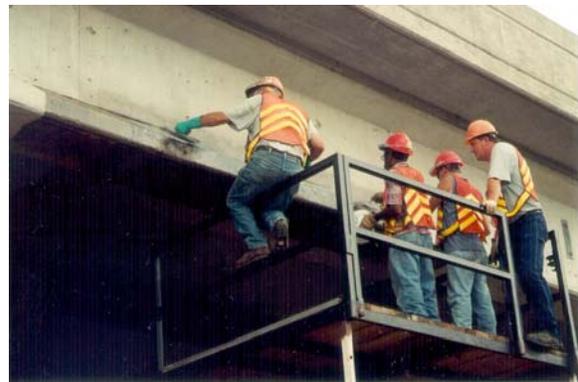
Figure 6 – MoDOT Personnel Applying MBrace Putty to a Damaged Girder

3. Putty Application: A very thin coat of MBrace Putty is smoothed over the surface to fill in any small voids, cracks or uneven surfaces (See Figure 6)

After the design had been completed and submitted the strengthening could be performed. In order to strengthen the impacted girders, they first had to be repaired. This consisted of applying concrete patches to those sections that had been damaged. Once the concrete had been repaired, the strengthening system could be applied.

A MoDOT bridge repair crew conducted the application of the CFRP strengthening as specified in the design. The MBrace Composite Strengthening System was the material used and was applied according to the manufacturer's recommendations (MBT 1998). A brief summary of the procedures for application of CFRP sheets is given below.

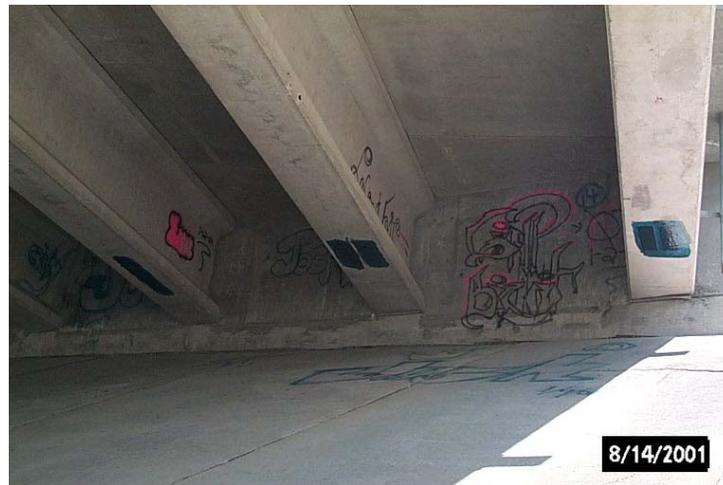
Figure 7 – FRP Strips for Bond Durability Testing

A team from the university installed five strips of CFRP on the bridge girder in a similar fashion to that adopted during the strengthening system installation. The five strips were installed at one end of the bridge away from the traffic lanes (see Figure 7) to avoid traffic disruption during testing. These strips will be used to perform a series of tests once every five years. The tests consist of bond pull-off and torsion tests and will help evaluate the performance of the installed strengthening over time.

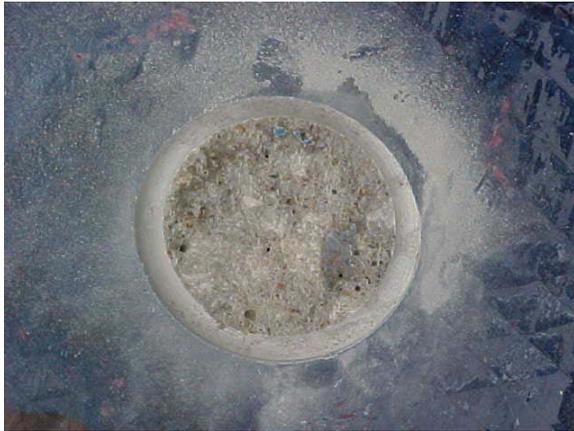
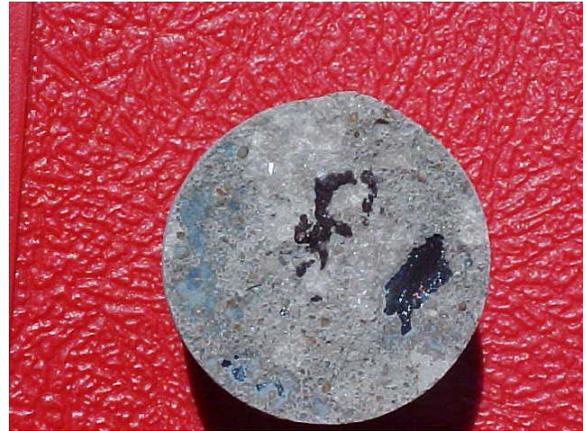
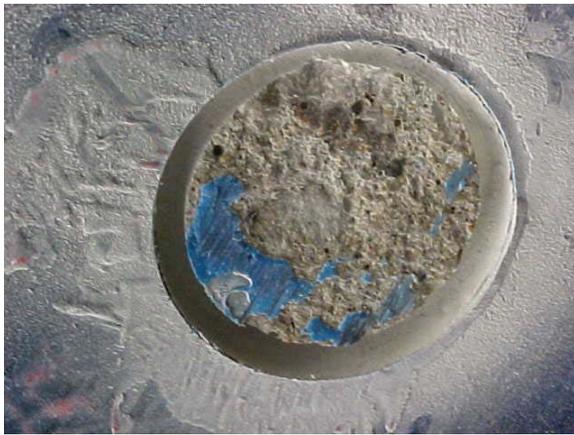
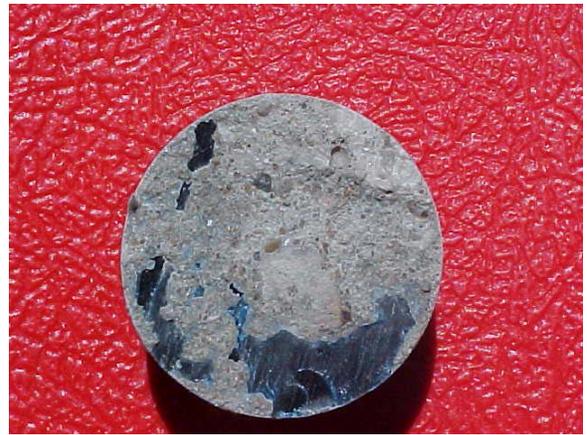
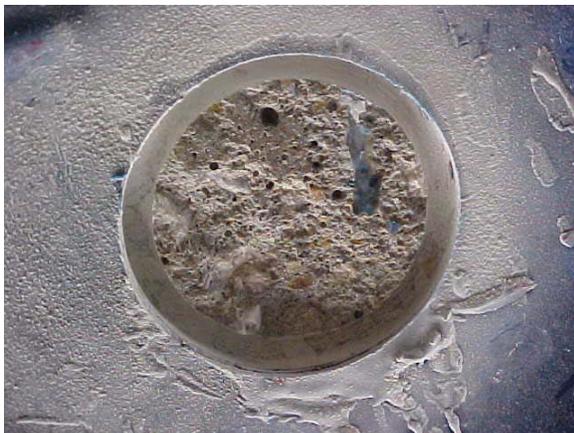
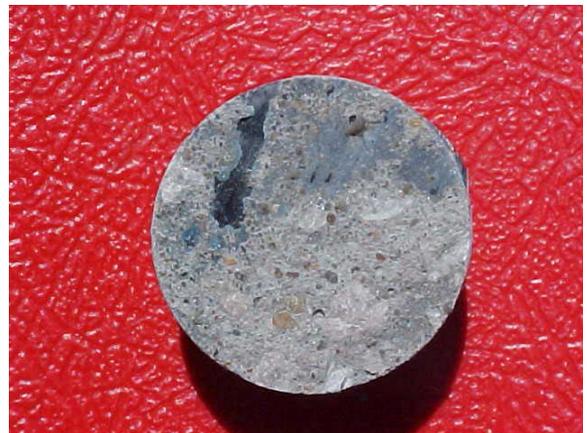
Figure 9 – Pull-off Test Results

The results of the pull-off tests conducted in August 2001 are given in Table 1. The load at which the specimen detached from the surface is given in the second column with the corresponding stress displayed in the third column. The ultimate stress (or bond tensile strength) is computed at the ultimate load divided by the fixture area. It is to be noted that according to ICRI recommendations, the minimum threshold is 200 psi; therefore, these results can be considered highly satisfactory. The results of the pull-off tests show that the failure was in the concrete indicating a strong bond between the FRP and the concrete surface. The approximate percentages of disk area as covered by concrete or exposed FRP is given in the fourth column of the table.

Pull-off Tests	Load (lb)	Stress (psi)	Disk Area Inspection
P1	1000	482	25% FRP, 75% concrete
P2	1200	579	30% FRP, 70% concrete
P3	1000	482	35% FRP, 65% concrete

Photos for the initial pull off tests are shown in Figure 9. The photos on the left display the locations of the pull-off test and the photos on the right display the sample discs.

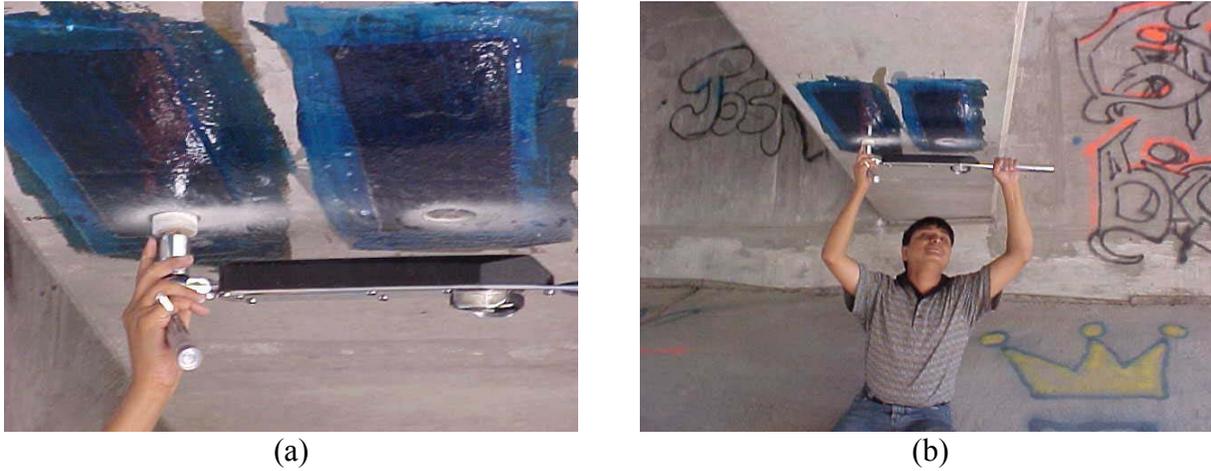
Figure 10 – Apparatus for Torsion Testing

To perform the torsion tests, special disks are adhered to the FRP with epoxy. The disks are identical to the ones used for pull-off, with the exception of a grid of 4 grooves to improve bonding of the adhesive to the steel surface. Similar to the pull-off test, the FRP was cut along the perimeter of the disk using a core drill. Torsion was applied using a calibrated torque wrench until the fixture separated from the surface (Figure 10a & 10b).

The shear stress that develops as the result of the applied torque has a triangular distribution with maximum at the external location and zero at the center of the circle. Due to this stress distribution, it is common practice to report the average shear stress equal to half the peak (Khataukar, 2001). The average shear stresses were calculated by taking the average of individual tests results with identical mode of failure.

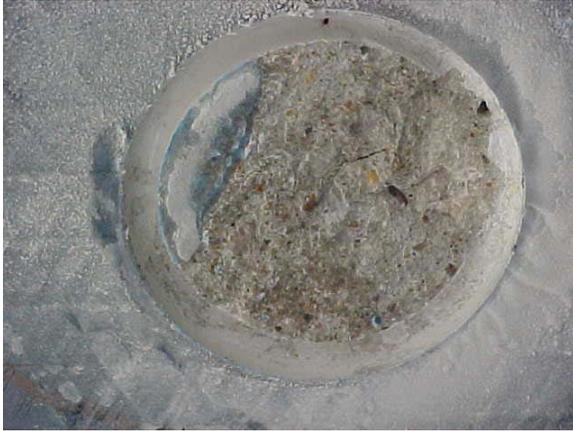
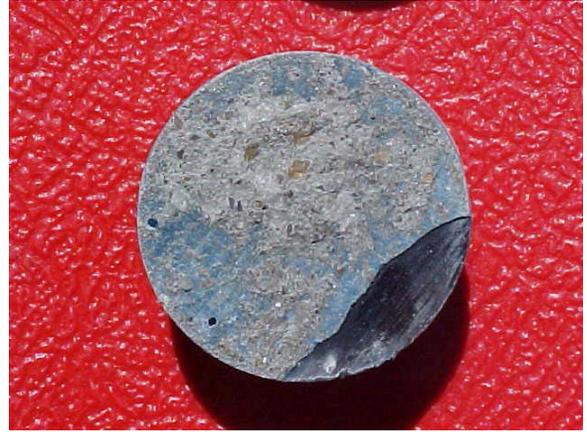
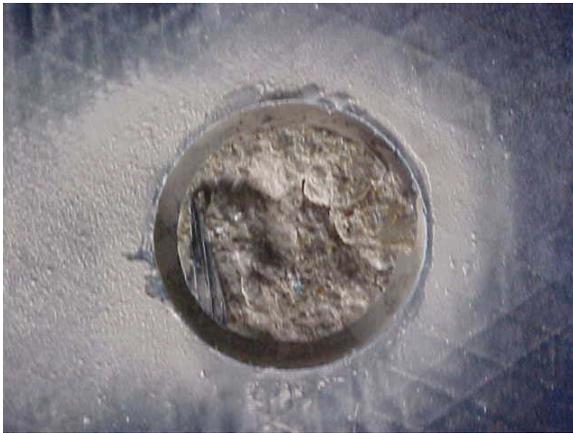
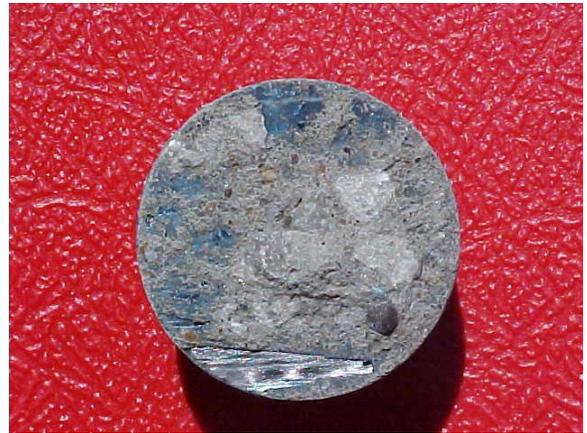
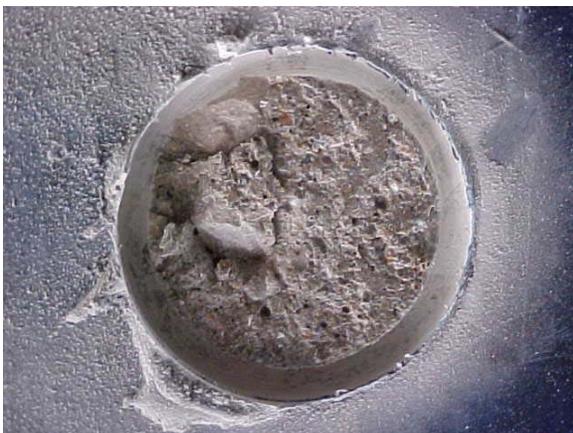
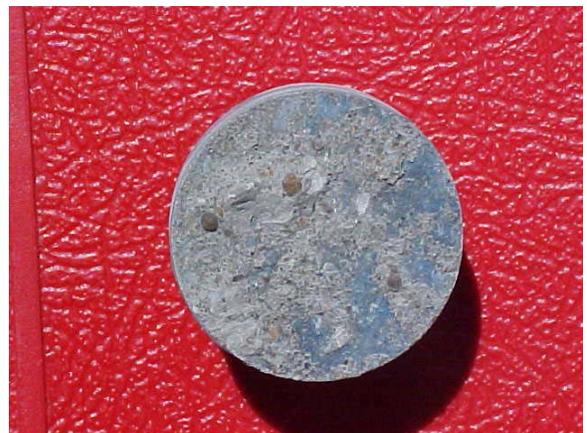
Figure 11 – Torsion Test Results

Three samples were used for the initial torsion tests. The results of the tests are given in Table 2 below. The torque at which the disc separated from the surface is given in the second column. The third column displays the corresponding ultimate stress or bond shear strength. The amount of disk surface area covered by the respective materials is given in column 4.

Torsion Tests	Torque (ft-lb)	τ_{max} (psi)	Disk Area Inspection
T1	75	534	60% FRP, 40% concrete
T2	95	676	50% FRP, 50% concrete
T3	100	712	45% FRP, 55% concrete

Figure 11 below displays the photos taken of the torsion test samples. The photos on the left show the locations of the torsion test specimens and the photos on the right show the torsion test discs.
